Re: Papa Johns
ADA Compliance Evaluation

As requested, I visited the above-referenced property to conduct visual observations in order to provide this ADA compliance evaluation of the KAIS ABID, d/b/a PAPA JOHN'S, KAM FOUR, INC, d/b/a PAPA JOHN'S, PARKER EAST 24th APARTMENTS, LLC and PARKER COMMERCIAL 24th ASSOCIATES and 305 EAST 24TH OWNERS CORP located at 432 Second Ave. New York, New York.

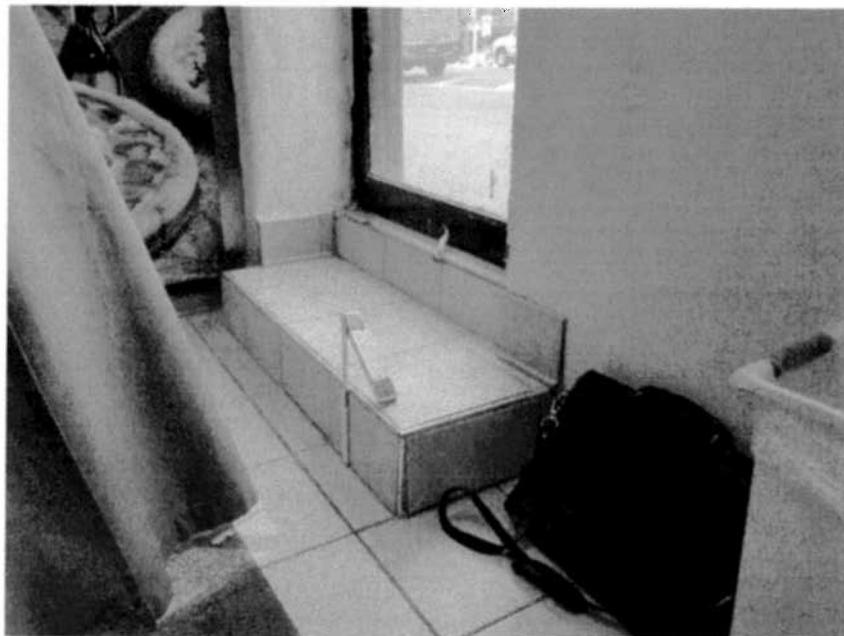
In order to enter the space through the entrance along the sidewalk of 2 Av., a person must descend two (2) steps of unequal riser height (6” and 7”) and unequal tread depth.

Picture 1: Store entrance, 6" and 7" stairs on entrance.

1. *Entrance steps and doorway:* To address this condition, a permanent small ramp can be constructed from the sidewalk level up to the main floor level; the ramp would require appropriate slope, railings, and signage as required by 28 C.F.R. 36 to provide an accessible and properly designated entrance. In the alternative, a wheelchair lift may be used. In the alternative, an ADA compliant portable ramp with a non-slip surface may be used in conjunction with ADA accessible signage and buzzer to comply with 28 C.F.R. Part § 36.304 (e).¹ A cost estimate of providing an ADA compliant wheelchair lift is approximately \$10,000.

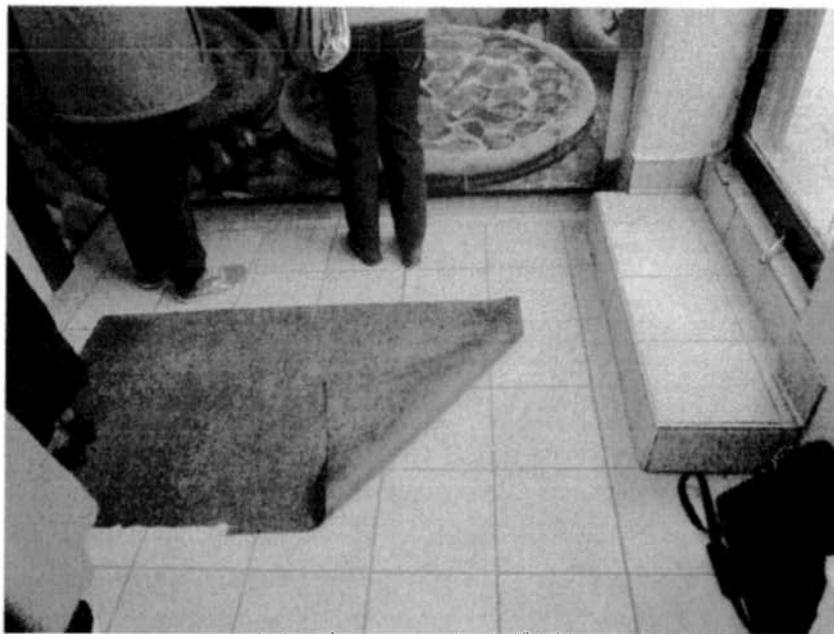
Picture 2: Unsecured entry mat

5. *Secured Mats:* The existing non ADA compliant mats in the store layout can be secured to be in compliance with 28 C.F.R. Part 36 and 2010 Standard, Section 302.2.

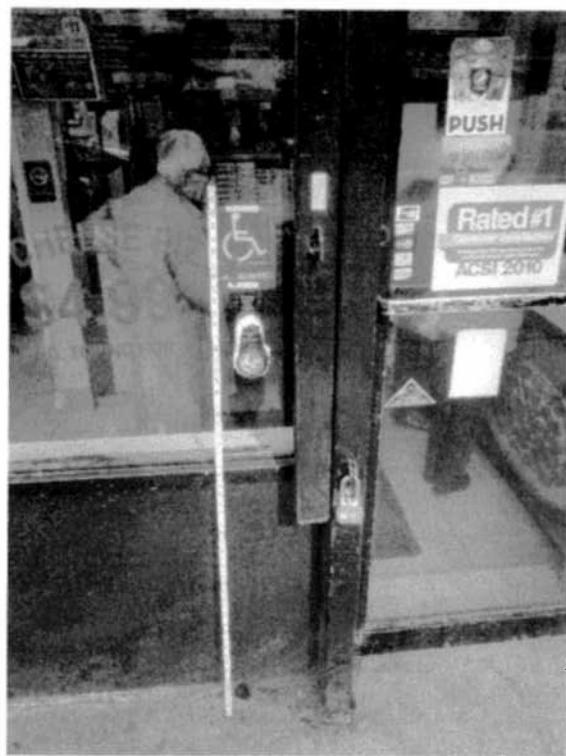
Picture 3: Inaccessible ADA signage and buzzer

4. *Signage:* Appropriate visual and/or tactile signage regarding services available should be provided to comply with 28 C.F.R. Part 36, Section 4.1.3(16) and 28 C.F.R. Part 36, Section 4.30.4. A cost estimate of providing appropriate signage is approximately \$200.

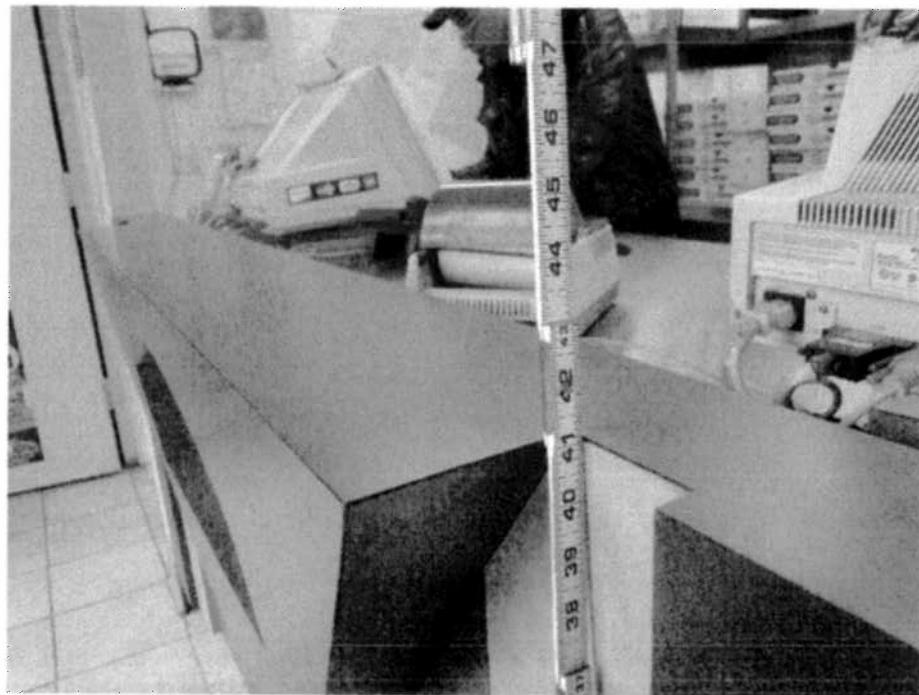
Picture 4: Inaccessible service and transaction counter 41" (h)

2. *Transaction counter:* The existing non ADA compliant transaction counter can be modified to comply with 28 C.F.R. Part 36, Section 7.2(1), which requires that a portion of the main counter (measuring a minimum of 36 inches in length) be provided, with a maximum height of 36 inches above the finished floor. The cash register display screens should be lowered with the transaction counter. A cost estimate of lowering the transaction counter is \$2,000.

3. *Service Counter:* The existing non ADA compliant service counter can be modified to comply with 2010 ADAAG, Section 902.3 which requires a portion of the main counter (measuring a minimum of 36" in length) be provided with a maximum height of 36" above the finished floor. The cost estimate of lowering the service counter is the same as the cost for lowering the transaction counter.
